TFYA21 Physical Metallurgy

Laboration Compendium

Fractography

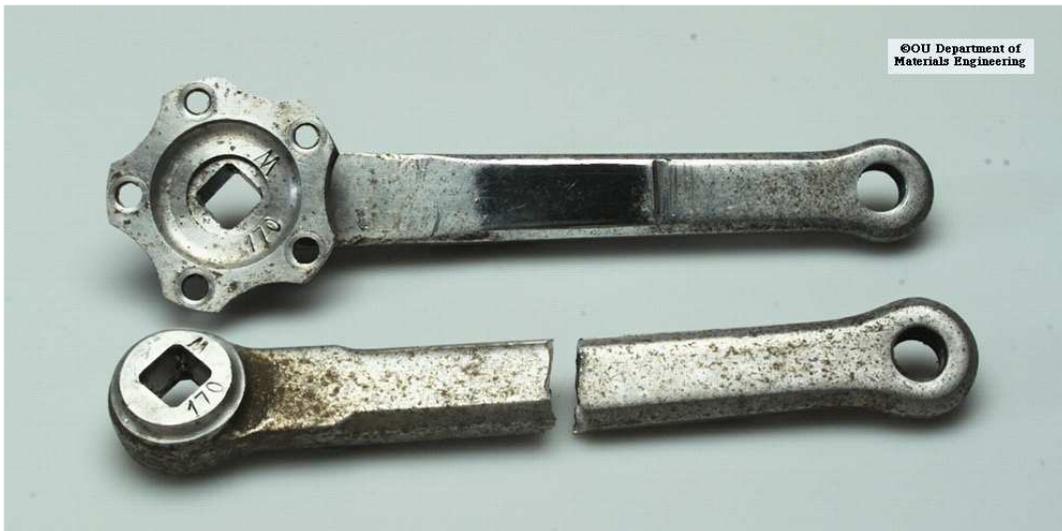
A broken bicycle pedal crank

What type of discussed failure mechanisms was a reason for the failure of a bicycle pedal shown on the cover?
